Dear Half-Mast:

Our unit mechanics disconnected the CTIS system on the up-armored M939-series 5-ton trucks and increased the tire pressure to 70 PSI manually.

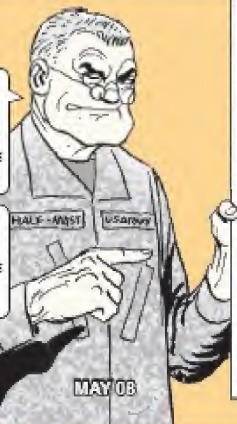
On M939A2's equipped with the original CTIS ECU, the tires are automatically inflated to 60 psi on non-wrecker models and 80 psi on wrecker models when the vehicle's highway mode is selected. On up-armored 5-tonners, the CTIS is disconnected, valve cores are installed, and the tires are inflated to 70 psi on non-wrecker models and 90 psi for wrecker models.

When the CTIS is disconnected on an up-armored 5-ton, there is no requirement to restore the CTIS to an operable condition. Leave it disabled. A disabled CTIS does not make the truck NMC during scheduled or unscheduled maintenance. You'll find this same info spelled out in TACOM SOUN 06-019. (See page 57 of this issue for more information.) Remember, mechanics should not remove CTIS components or toss them out.
